SPECIAL REPORT

Moisture in the Roofs of Cold Storage Buildings

Wayne Tobiasson and Alan Greatorex

November 1998

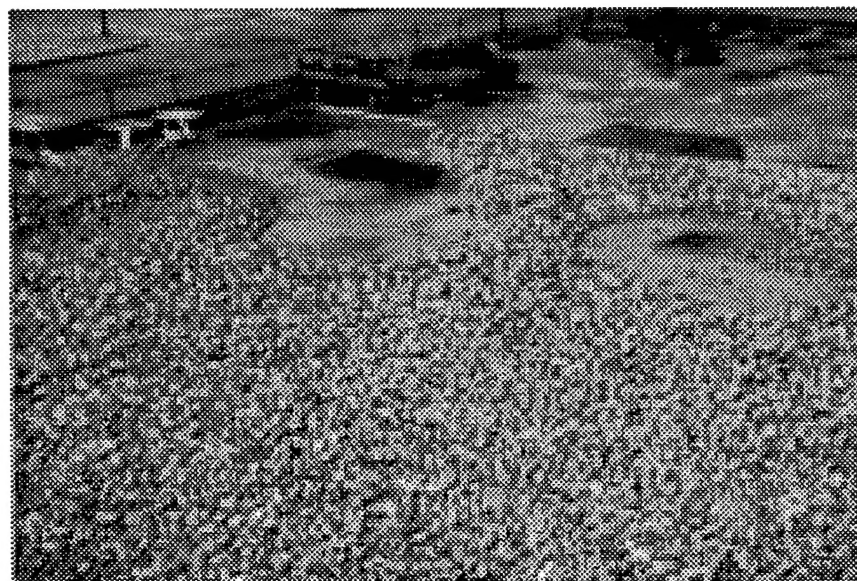
The daytime visual inspection revealed that ballast scour by wind existed in the northwest corner (Fig. 4); a portion of the north edge metal was depressed below the level of the membrane (Fig. 5); and a failed patch (Fig. 6) existed along the north edge 115 ft (35 m) from the northwest corner.

Figure 4. Ballast scour in the northeast corner of roof D1.

Most of the waterproofing membrane on this roof is in good condition. It may be wise to revise the north edge of this roof to eliminate the problem shown in Figure 5. It may also be appropriate to replace the stone ballast with roof pavers in the

northeast and northwest corners, and perhaps all along the north edge, to prevent ballast scour there. Pavers are more stable in high winds.

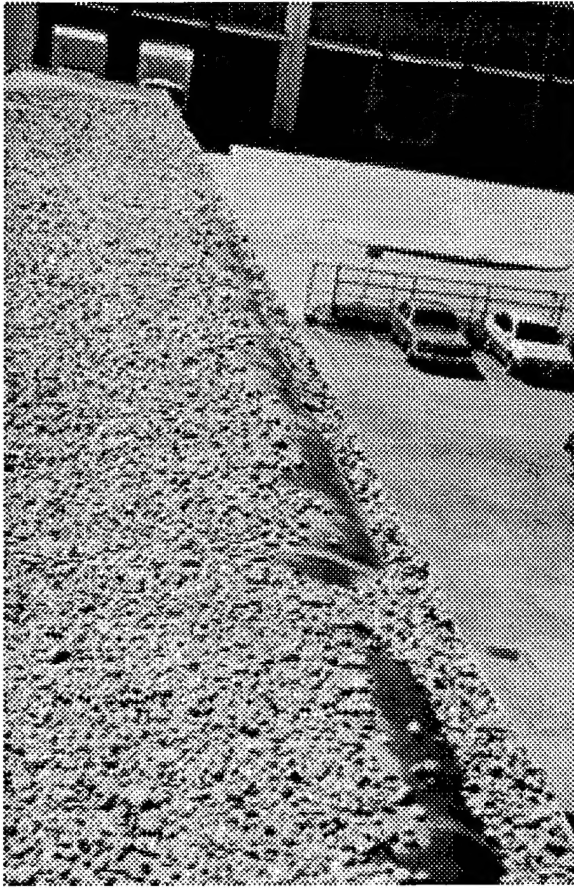
Figure 5. Depressed edge along a portion of the north side of roof D1, looking west.

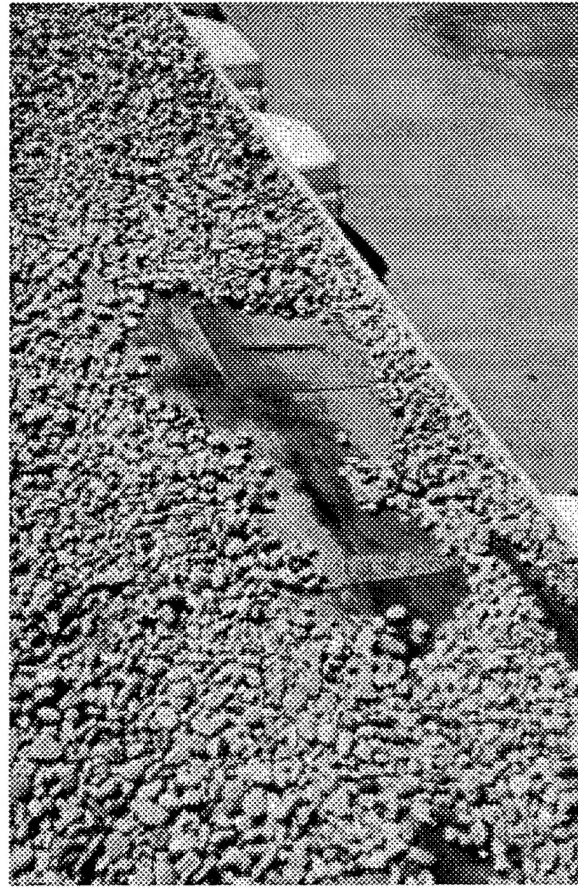
Figure 6. Failed patch along the north edge of roof D1, looking NW.

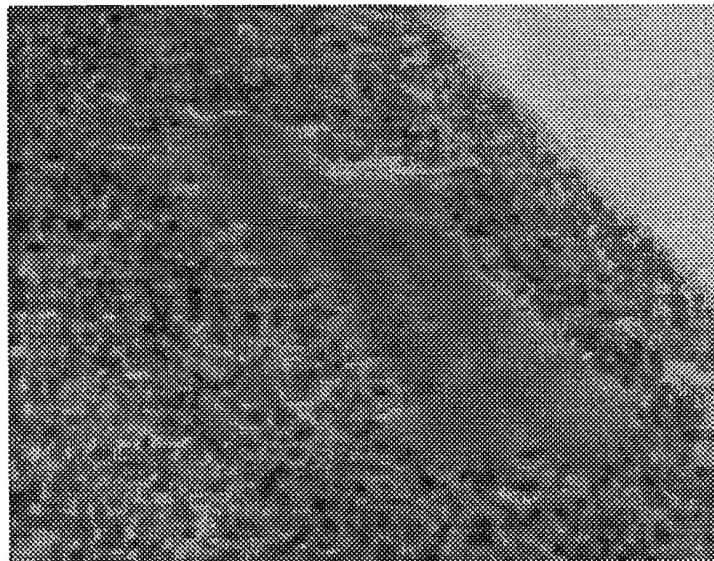
The nighttime on-the-roof infrared survey uncovered only a small area of brightness (Fig. 7) at the failed patch shown in Figure 6. Finger probing into the flaw revealed that wet insulation ex-

Figure 7. Thermal image (thermogram) of the failed patch shown in Figure 6, looking NW.

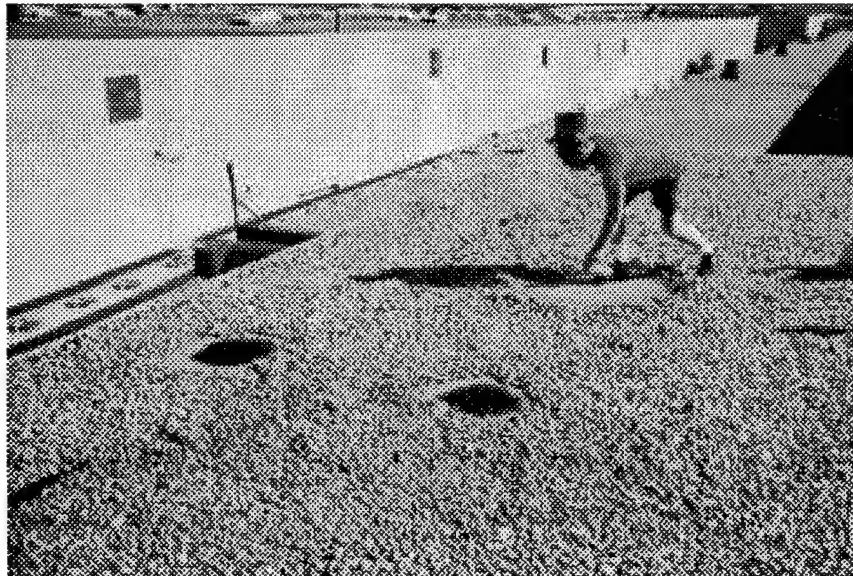
Bright areas were also detected by the infrared scanner in the southeast corner of this roof. Core samples 1, 2, and 8 and roof cut A were taken in this area (Fig. 2). Table 1 presents all core sample findings for this roof. The bottom 1 to 3 in. (2.5 to 7.6 cm) of fibrous glass insulation in this area was frozen "solid" (i.e., it was full of ice). Figure 8 shows the two areas of cleaned membrane where

Figure 8. Southeast corner of roof D1 showing areas cleaned for cores 1 and 2 and a larger area being prepared for core 8 and cut A, looking SE.

Figure 2 shows where 12- × 12-in. roof cut A was made. Results of tests run on the components of that cut are presented in Table 2. Core 8 was taken at the same place as cut A. Both found the expanded polystyrene insulation and the upper layer of fibrous glass insulation to be dry. However, the lower layer of fibrous glass obtained in cut A contained considerably more moisture than the similar layer in core 8 (14.8% vs. 1% by weight). In all likelihood, some of the wet fibrous glass below was collected in the cut while it was all left behind in the core. Prior CRREL studies (Tobiasson et al. 1991) indicate that fibrous glass with a moisture content of 14.8% by weight would have about 93% of its dry insulating ability (i.e., it would have a Thermal Resistance Ratio [TRR] of 93%). However, the TRR obtained by measuring the insulating ability of these fibrous glass specimens before and after drying them was only 36%. Differing test

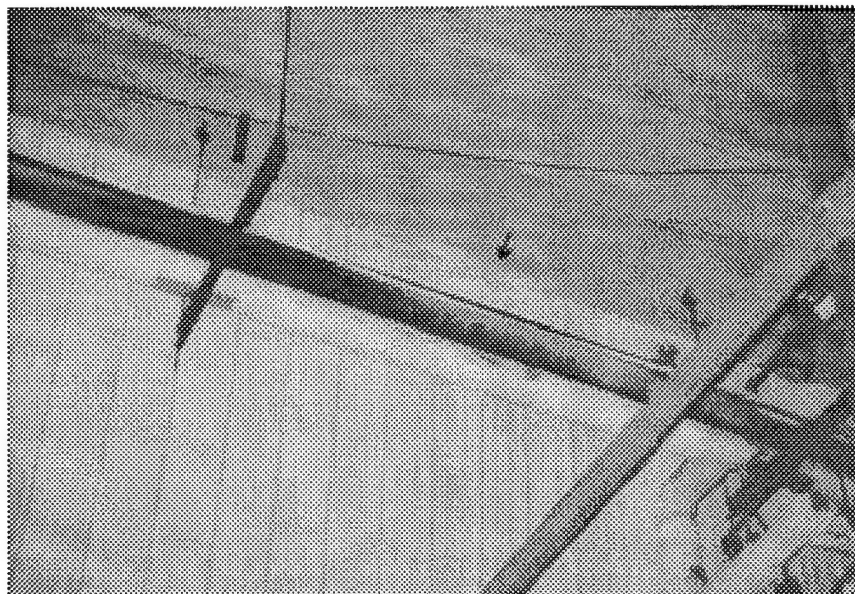
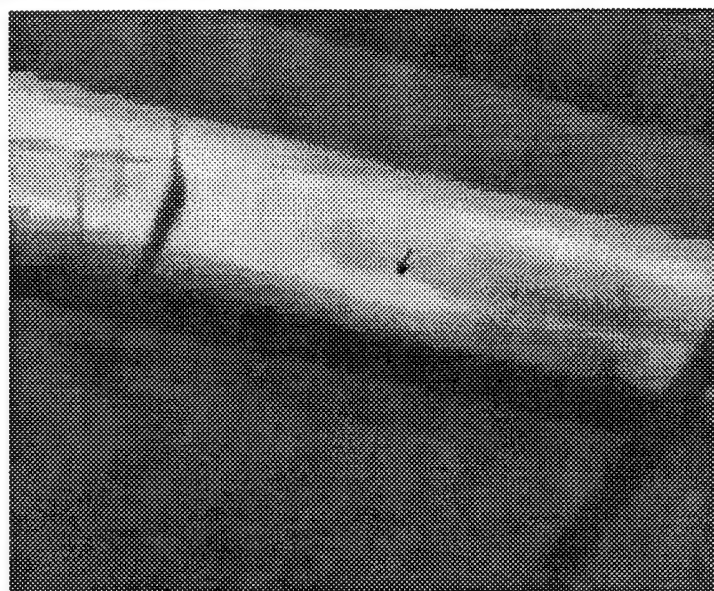
Figure 10. Photograph and thermogram from within the D1 freezer, showing ice and air infiltration where the roof and wall join.

a photograph and a thermogram of the area along the north side of the building where the roof and wall join. Ice is visible in the photograph and the bright thermal image indicates that warm outdoor air is leaking into the freezer along this seam. Figure 11 shows similar images taken of the northeast corner. Frost has accumulated there as warm outdoor air infiltrates into the freezer. Figures 10 and 11 indicate that air infiltration is occurring along the roof-wall intersection. The next time this freezer is warmed up, it may be appropriate to take steps to seal this joint. Spraying it with polyure-

thane foam may be worth considering. Warming this freezer could also be used to melt the ice in the fibrous glass insulation. The meltwater would probably leak out of the roof between the concrete double-tees, thereby drying out the wet fibrous glass insulation and recovering much of its lost insulating ability.

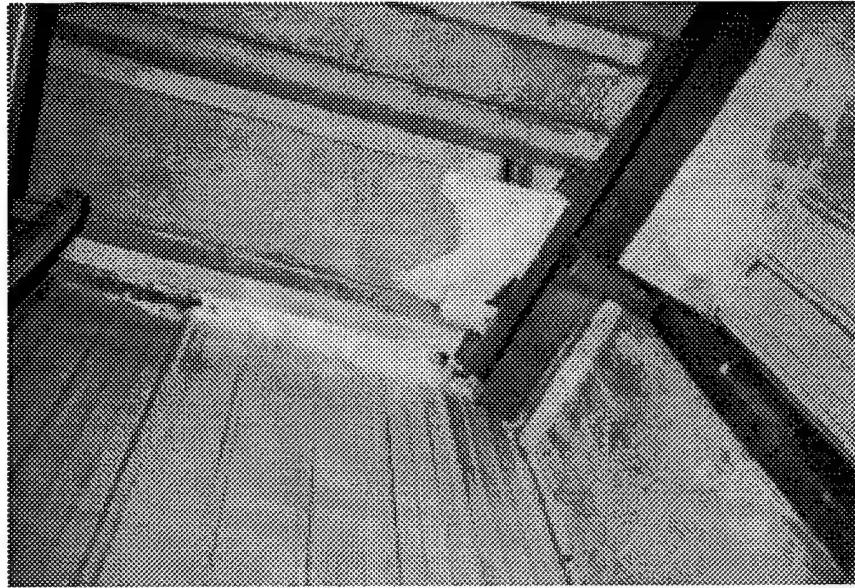
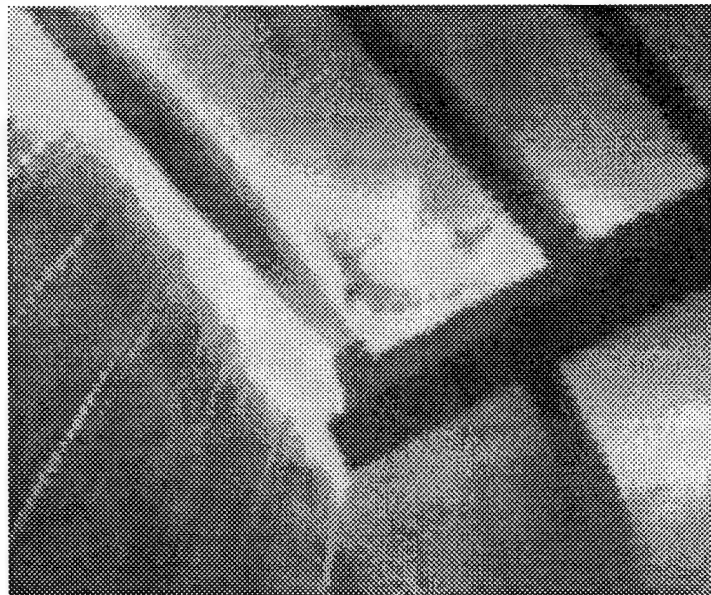
Figure 11. Photograph and thermogram from within the D1 freezer showing frost, ice, and air infiltration in the northeast corner of the D1 freezer where the two walls and roof join.

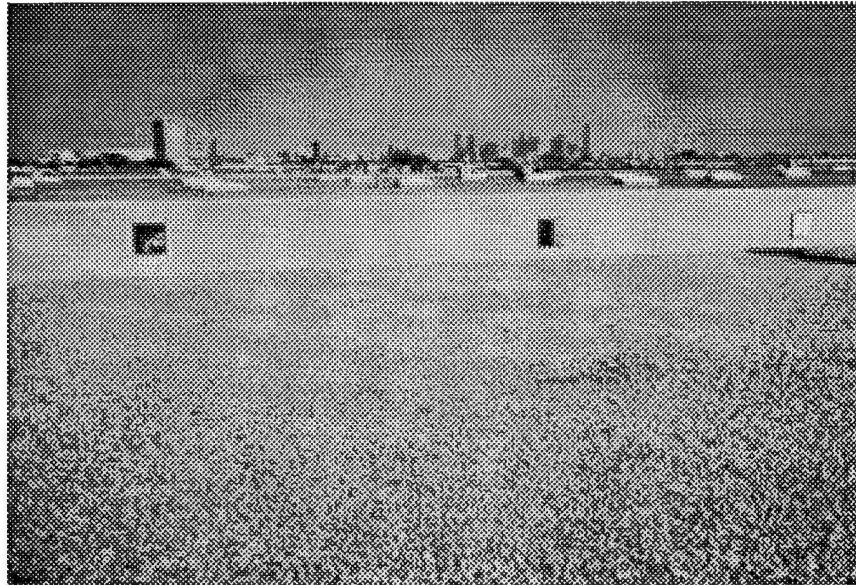
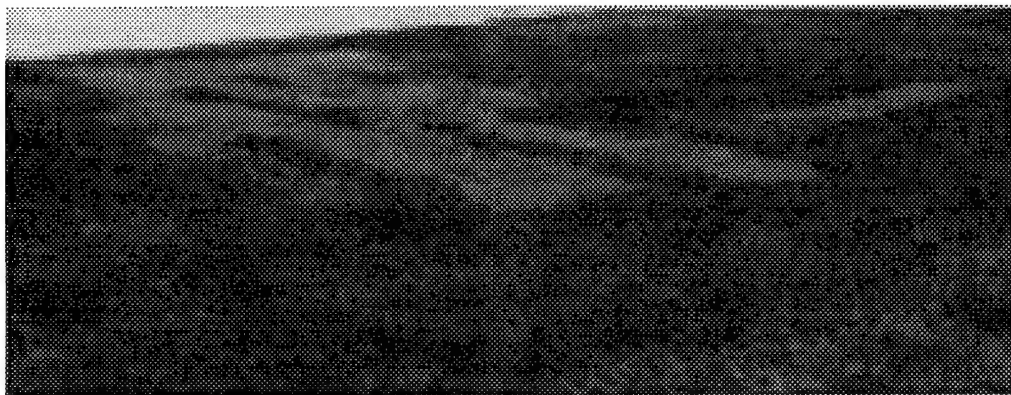
The daytime visual inspection revealed no roofing defects. During the nighttime on-the-roof infrared survey, large bright thermal anomalies were detected in the southeast corner. A few marks were made with orange spray paint there to define the general extent of these bright areas. Figure 12 shows a photograph and a thermogram of this corner of the roof. Figure 13 shows a photograph and a thermogram of a small rhombic anomaly also in this general area. That wet area is also visible at

Figure 12. Photograph and thermogram of the southeast corner of roof D2, looking SE. The bright area on the thermogram defines where wet EPS insulation exists below the EPDM membrane.

the right edge of Figure 12. Table 3 presents all core sample findings for this roof and Table 4 presents findings for cut B. Cut B and core 3 were taken at about the same place but far enough apart to experience significant differences in moisture. The EPS insulation *above* the old membrane was wet at three of the four places sampled. Solar energy stored in the wet EPS caused this surface to be warmer there when we surveyed it. The new EPDM membrane probably is (or was) flawed here. No obvious flaws (or patches) were detected but some must be present. The ballast would have to be moved aside in this area to find them. If flaws are not found and eliminated, the amount of wet EPS insulation in this roof can be expected to increase. We also detected a small (2-ft [0.6-m]

Leaving the wet insulation in this roof not only reduces its insulating ability but it also accelerates its rate of deterioration. It would be expensive to remove and replace all wet EPS insulation, but this option should be considered since this insulation cannot be dried out in place. The bituminous membrane below prevents downward drying.

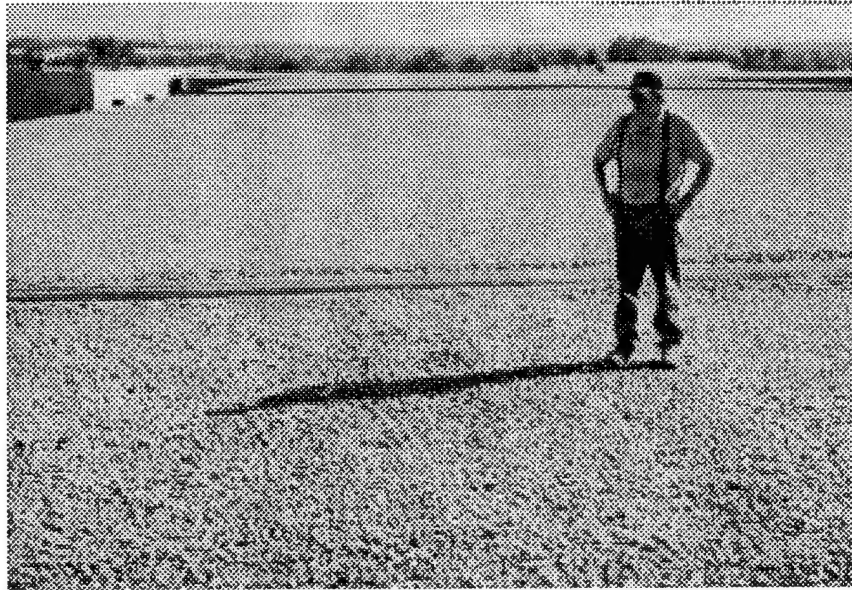
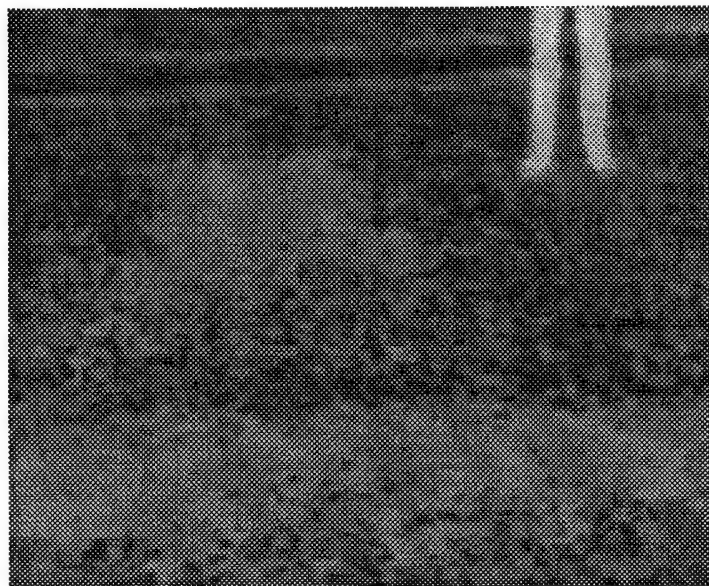
The upper couple of inches of fibrous glass insulation were dry over the entire roof but, in 2 of the 4 places sampled; the lower 2 to 5 in. (5 to 13 cm) of that insulation was full of ice. At cores 3 and 6, where both the EPS and a portion of the fibrous glass were wet, the roof had lost about half of its insulating ability. All these problems are within a 40- \times 40-ft (12.2- \times 12.2-m) area at the southeast corner of this roof. Currently, as evidenced

Figure 13. Photograph and thermogram taken near the area shown in Figure 12, looking south.

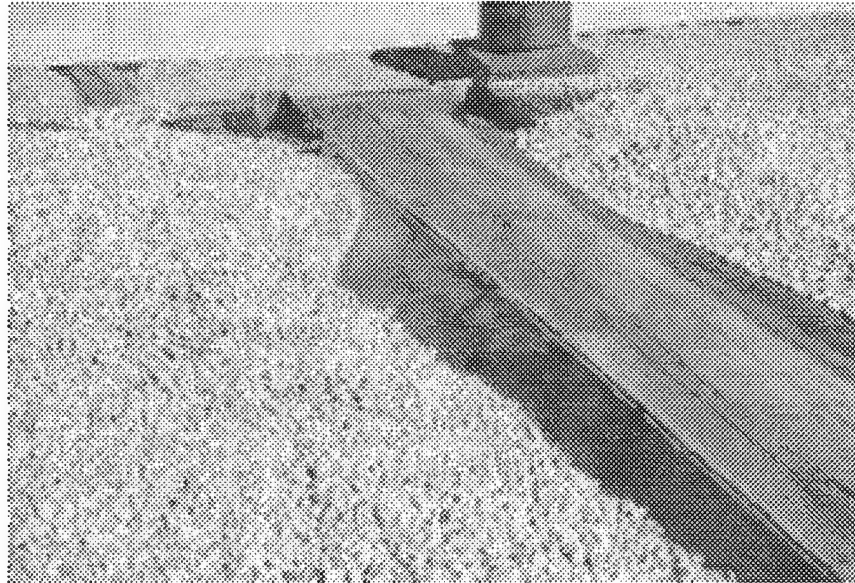
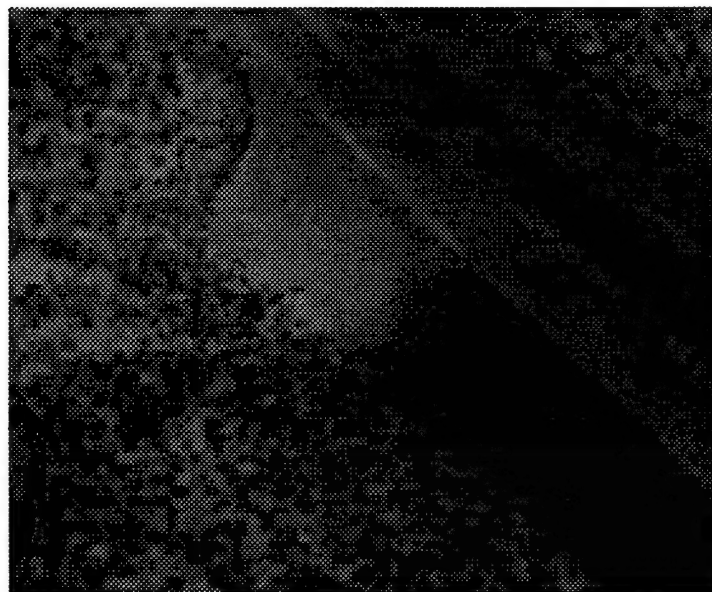
A photograph and thermogram of the east end of the expansion joint that forms the south end of roof D2 are shown in Figure 14. The insulation did not feel soft (i.e., wet) within the bright area of the thermogram. This and other evidence suggests that this warmth was caused by air infiltration from the edge of the roof. As stated for roof D1, if

Figure 14. Photograph and thermogram of the east end of the expansion joint at the southeast corner of roof D2. The intense brightness on the thermogram is probably due to air infiltration, not wet insulation.

and when this freezer is warmed up, such air infiltration paths should be blocked.

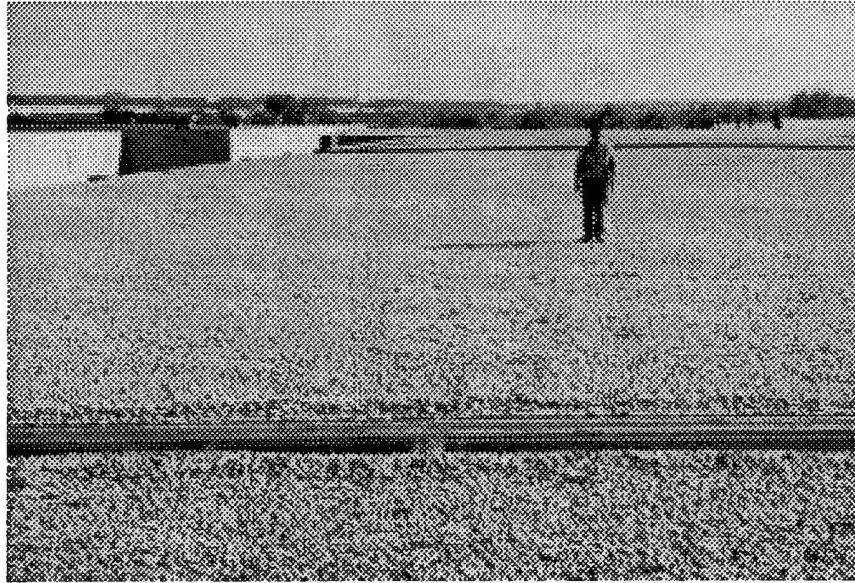
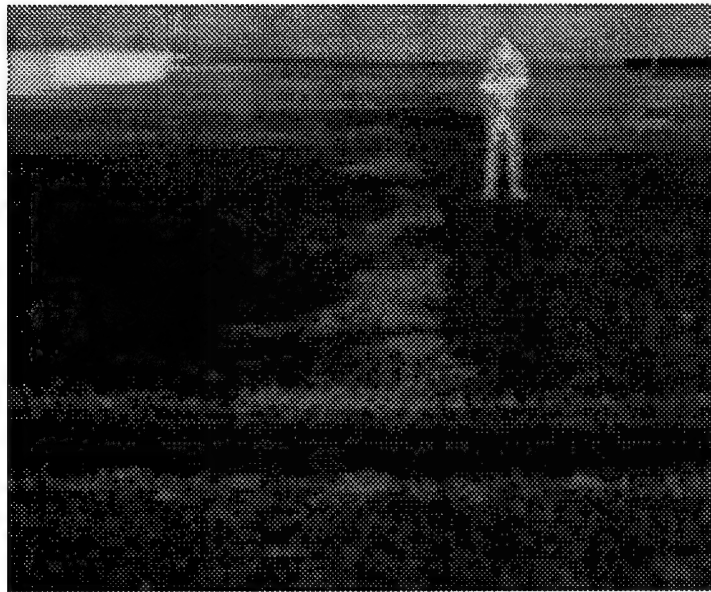
ure 14. Figure 15 shows it again along with the bright thermal image that extends from it onto this roof. A few orange spray painted marks were made on the roof to indicate where this bright 2-ft-wide, 52-ft-long (0.6- × 16-m) strip is located. It is parallel to and about 50 ft (15.2 m) from the east edge of this roof. We did not core the roof in this area, so we do not know for sure if it contains wet

insulation. Our uncertainty is due to differences in ballast color in this area, which are also, in part, responsible for the bright thermal images. The owner may wish to investigate this further to determine if wet EPS or wet fibrous glass is present since, as stated for roofs D1 and D2, moisture in each insulation should be responded to in a different way. If the EPS is wet, the EPDM membrane

Figure 15. Roof D3, looking south from the expansion joint that separates it from roof D2. The bright area on the thermogram may indicate the presence of wet insulation.

should be inspected closely with the goal of finding the flaw(s) where water bypassed the waterproofing system.

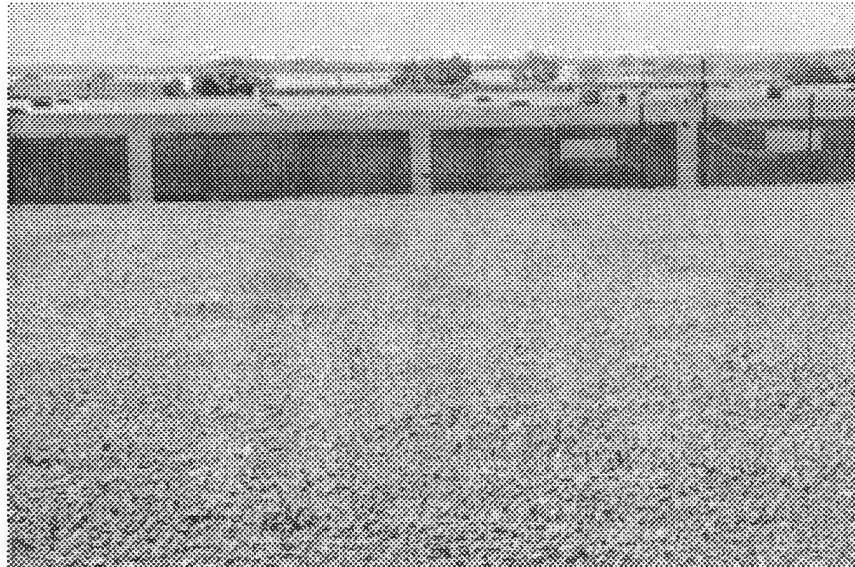
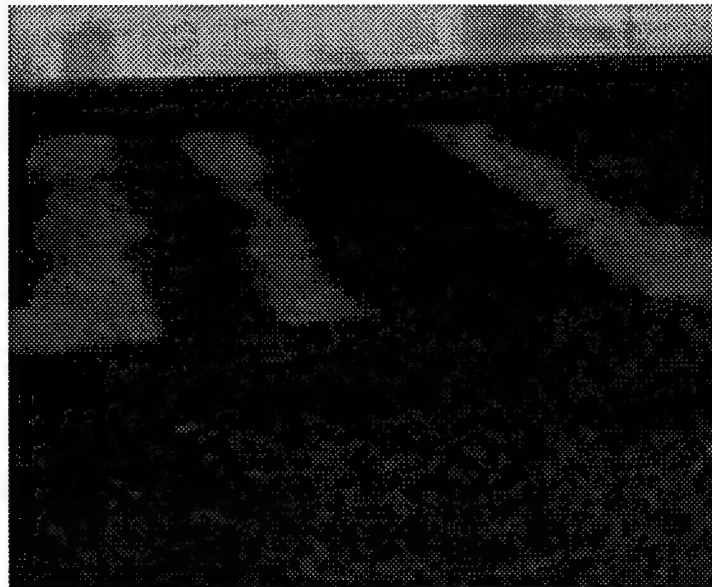
The western half of this roof contained numerous parallel bands of brightness when viewed with the infrared scanner. Figure 16 shows a photograph and thermogram of three such bands. They were all caused by differences in the ballast. All

bright areas correspond to bands of dark ballast as can be seen in the Figure 16 photograph. Core 10, the only sample taken on this roof, was taken in one of the bright areas to verify that all the brightness was caused by dark ballast. Its location is shown in Figure 2. Table 5 presents the information obtained at core 10. It verified that these bright bands were *not* moisture related.

Figure 16. Roof D3, looking west. The bright bands on the thermogram are due to dark ballast in those areas as shown in the photograph. Core 10, taken in one of the bright bands, verified that the brightness is not due to wet insulation.

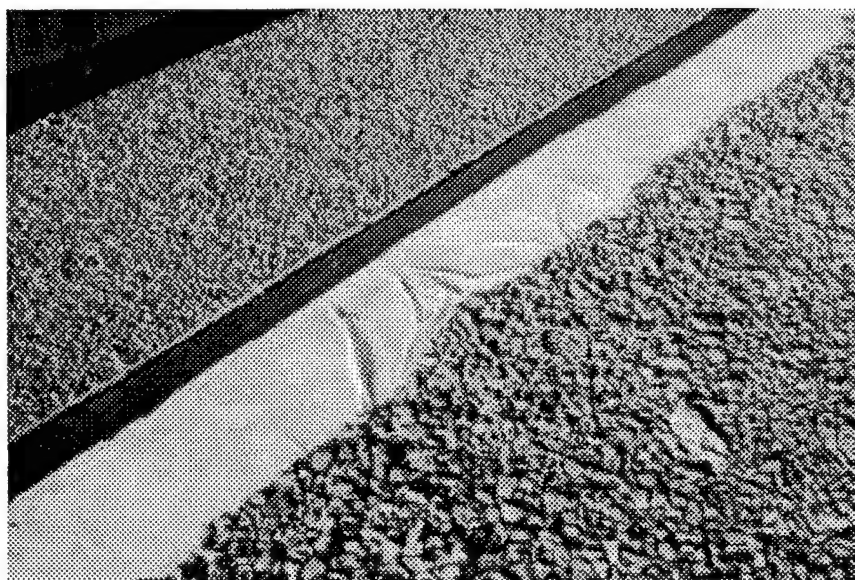
Figure 18. Raised edge of roof D5 showing wrinkled Hypalon.

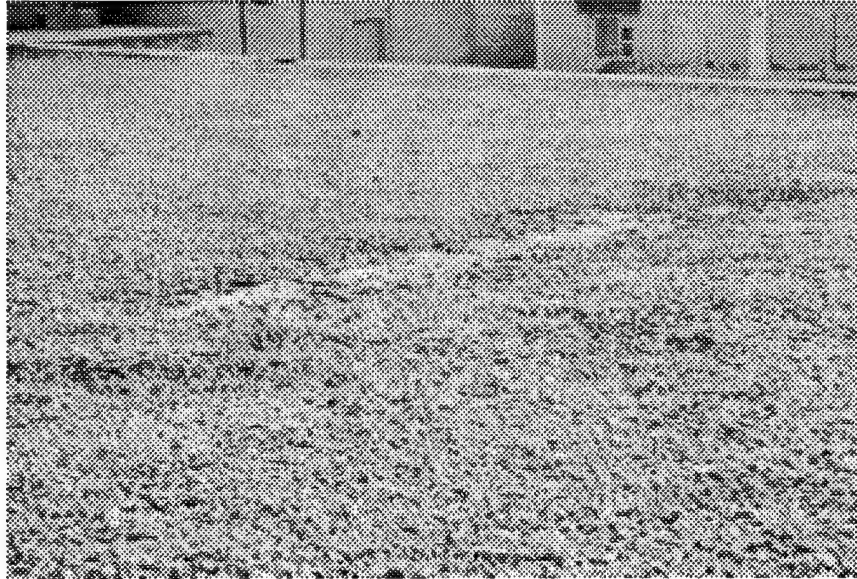
Figure 19. Bare area on roof D5, looking southwest.

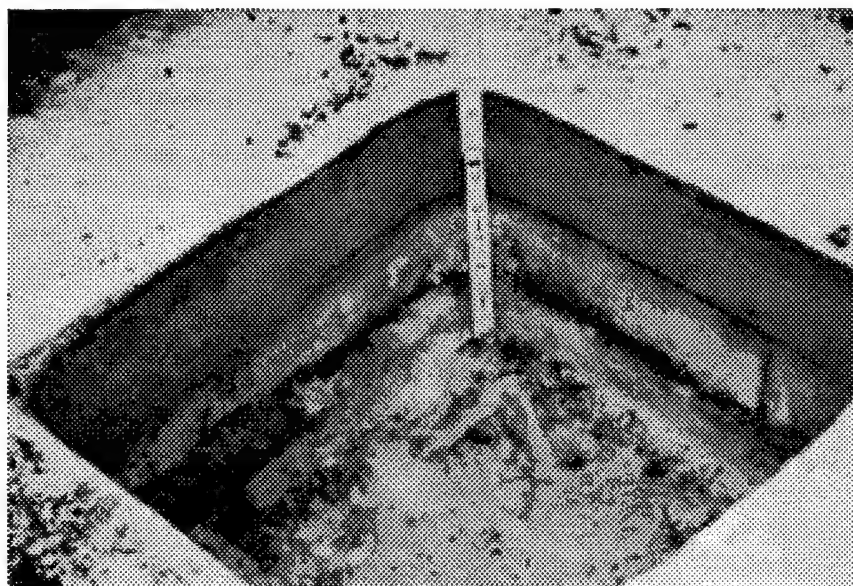
Figure 21. Cut D on roof D5 showing layers of perlite and fibrous glass insulation.

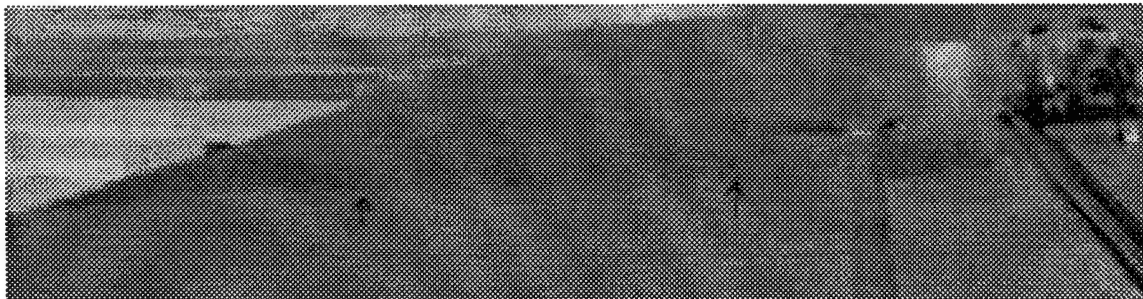
Figure 24. Thermogram showing the cold band caused by movement of cold water from refrigeration equipment across roof D7, looking north.

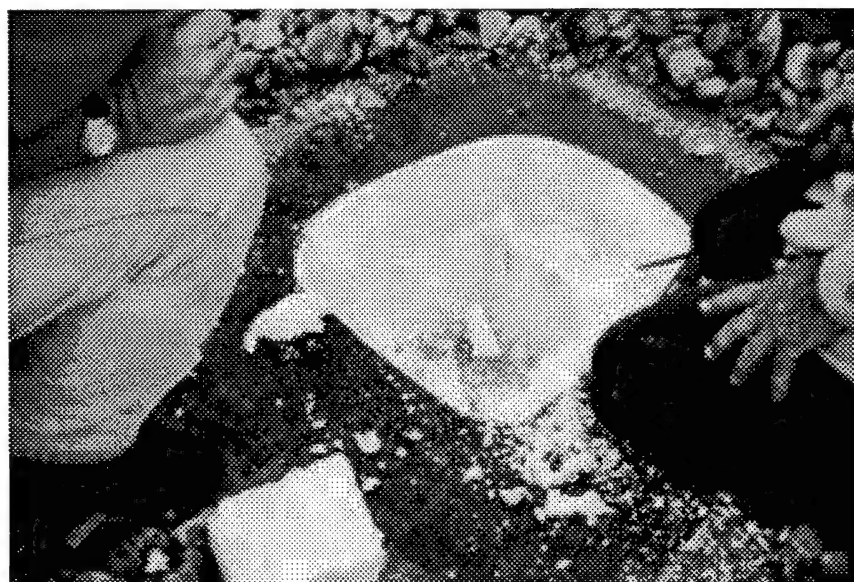
Figure 25. Taking cut F on roof D7. The lower layer of EPS was "full" of ice and frozen to the deck. A 12- x12-in. sample of it could not be obtained.

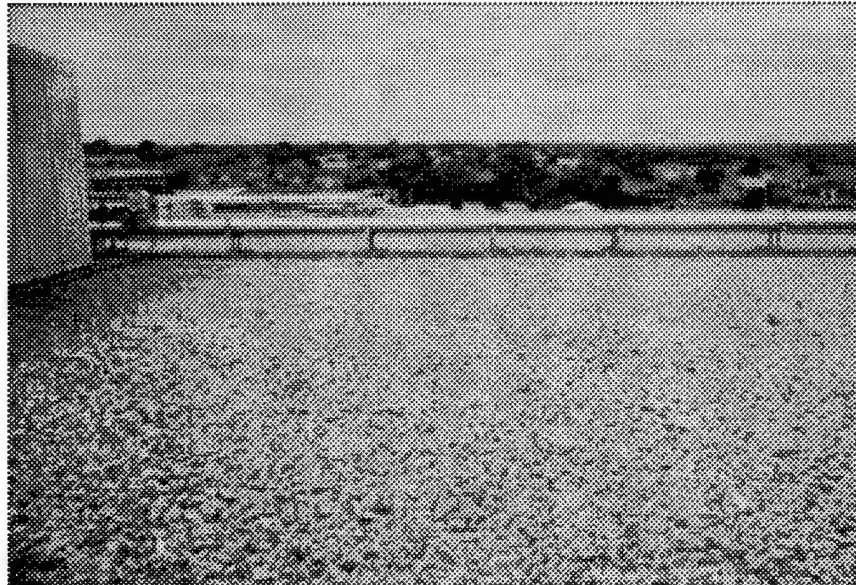
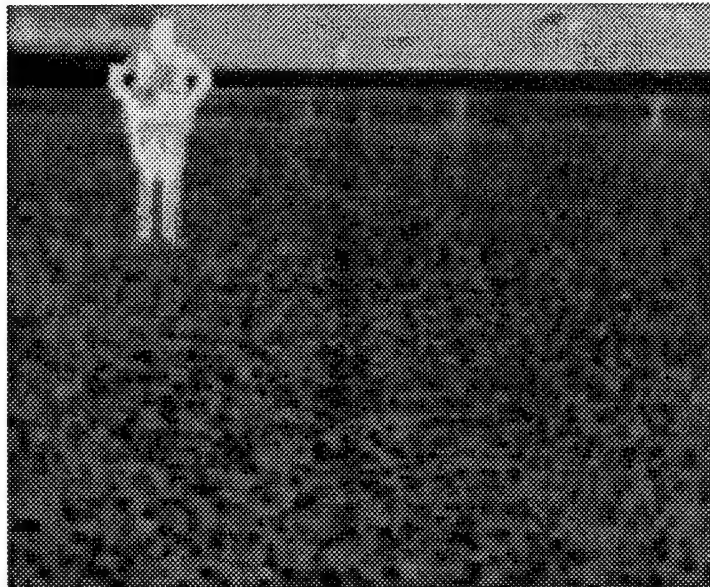
Figure 26. Photograph and thermogram of roof A1, looking west. The dark line in the thermogram is a hidden expansion joint.

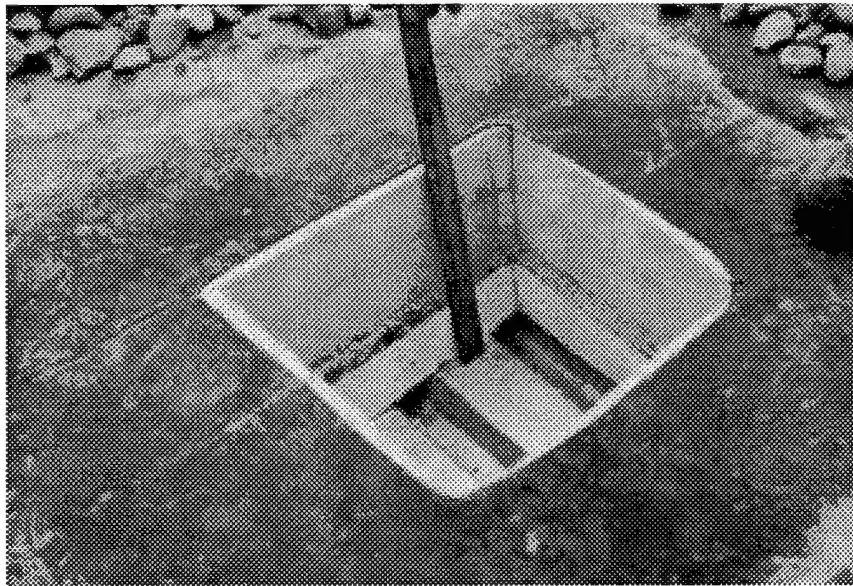
Figure 27. Hole made in roof A1 when taking cut G. No rust existed on the steel deck.

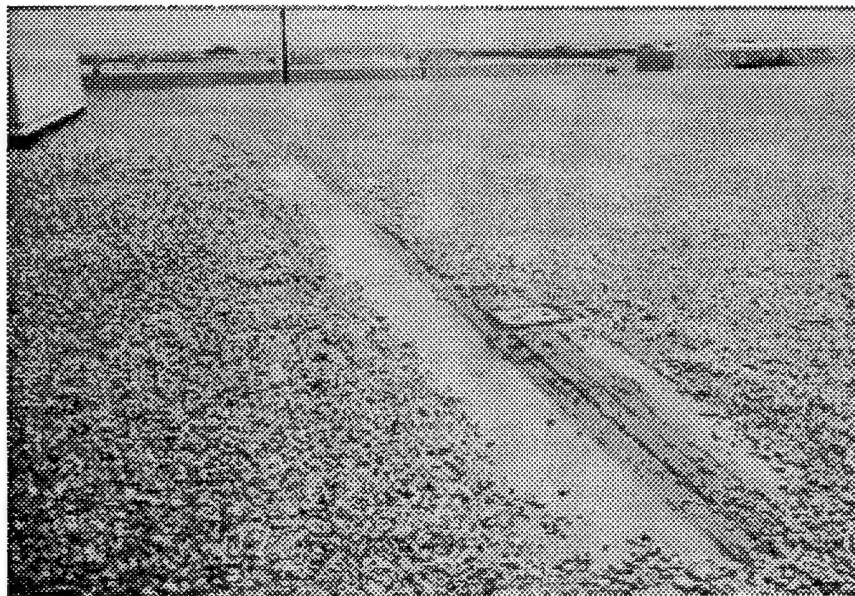
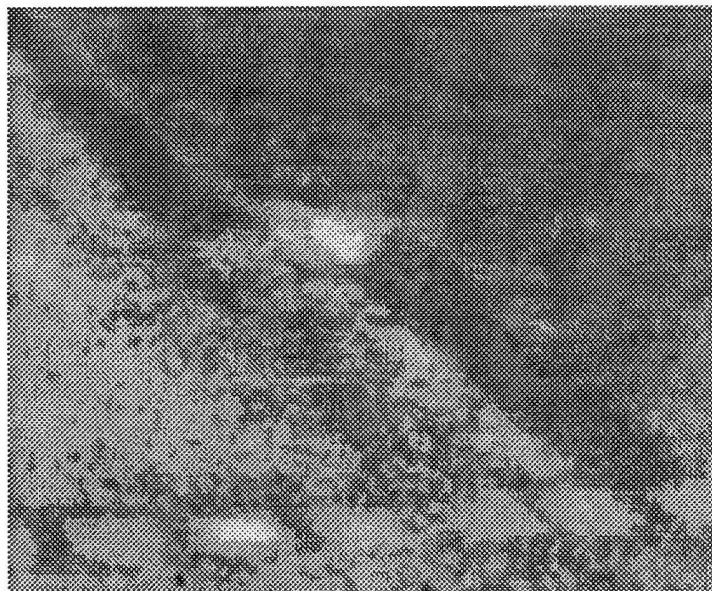
Figure 28. Photograph and thermogram of the expansion joint that separates roofs A2 and A3, looking a little south of east. The bright spot on the thermogram suggests that wet insulation exists below the patch.

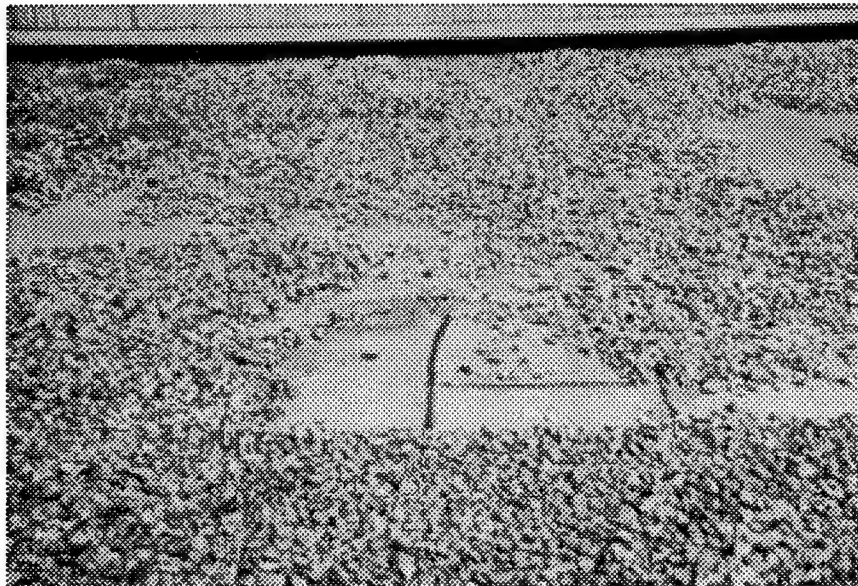
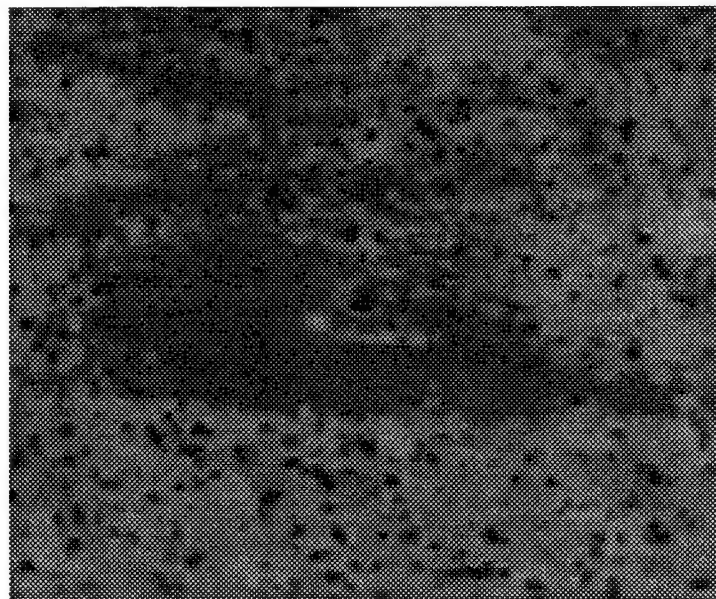
Figure 29. Photograph and thermogram of disturbed ballast on roof A2, looking north. The spray painted lines outline some insulation boards and the dot is where core 18 would soon be taken. Insulation was wet there.

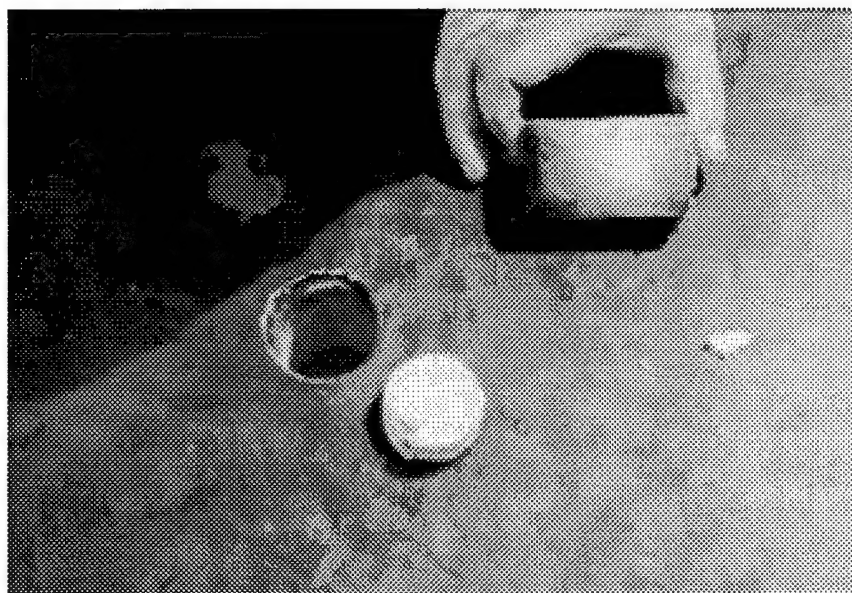
Figure 30. Upper layer of phenolic insulation at core 18.

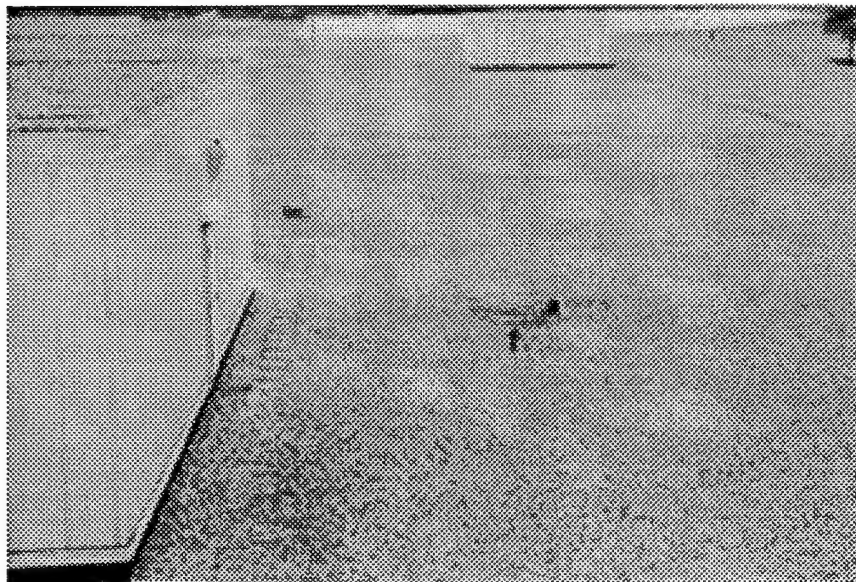
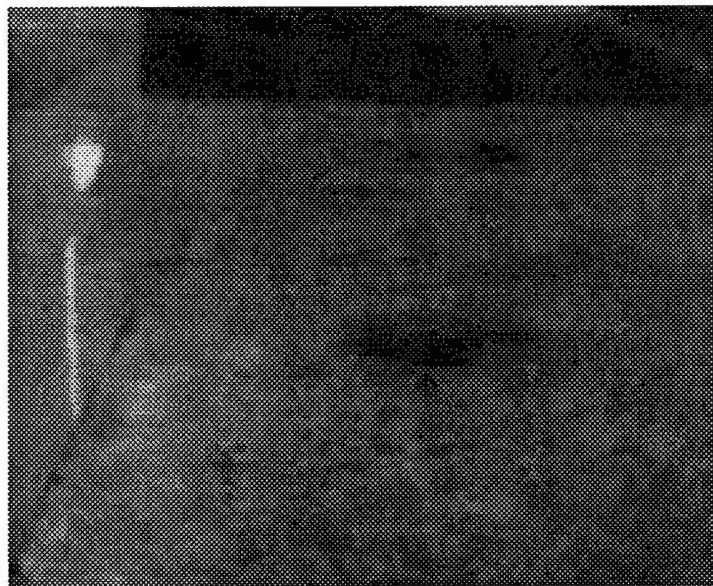
Figure 31 shows a thermally dark area to the west of the west penthouse on this roof. The photograph and the thermogram were taken from roof A1, which is about 9 ft (2.7 m) higher. Core 17 was taken in the middle of that dark area. As indicated in Table 16, core 17 contained wet phenolic insulation. We did not remove ballast in this area to search for the membrane flaw through which that

Figure 31. Photograph and thermogram of a strong thermal anomaly on roof A2, looking south. Core 17, taken here, found wet insulation.

moisture entered the roof. We expect that a search will find it within a 4-ft radius of the patch we made in the membrane where core 17 was taken.

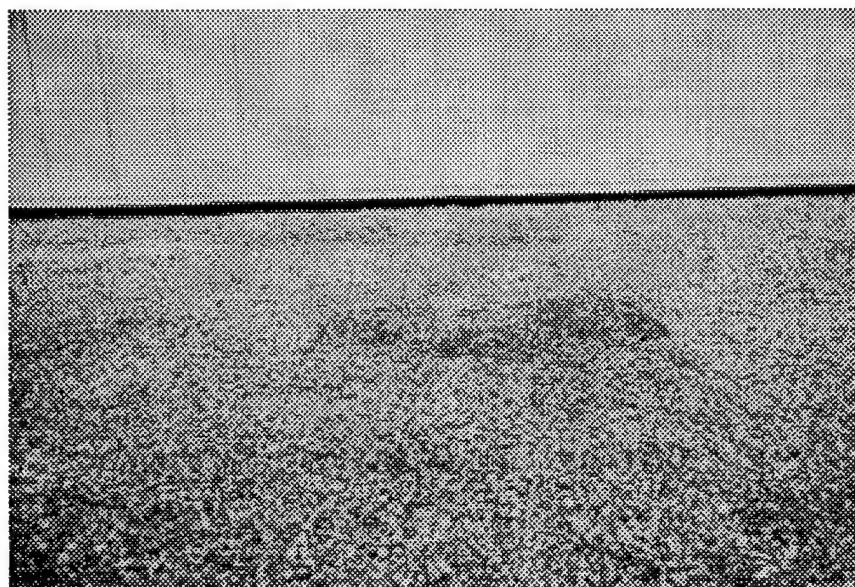
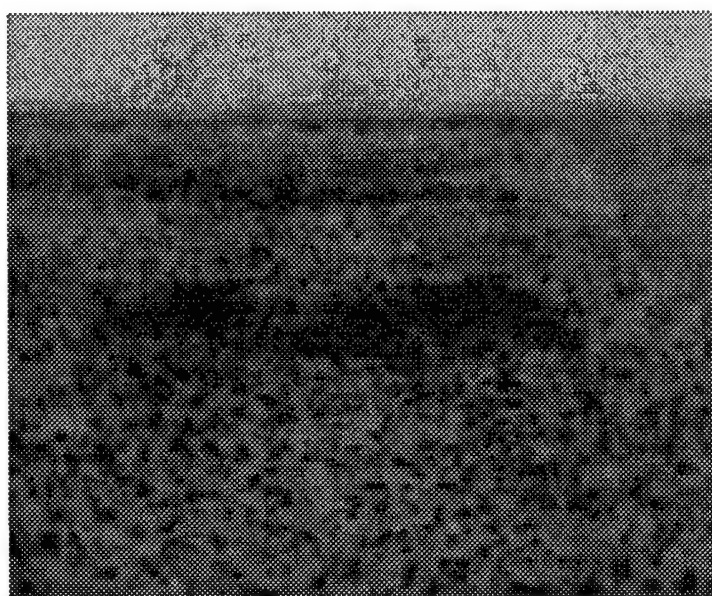
Figure 32. Photograph and thermogram of another strong thermal anomaly on roof A2, looking north. Core 19, taken here, found wet insulation.

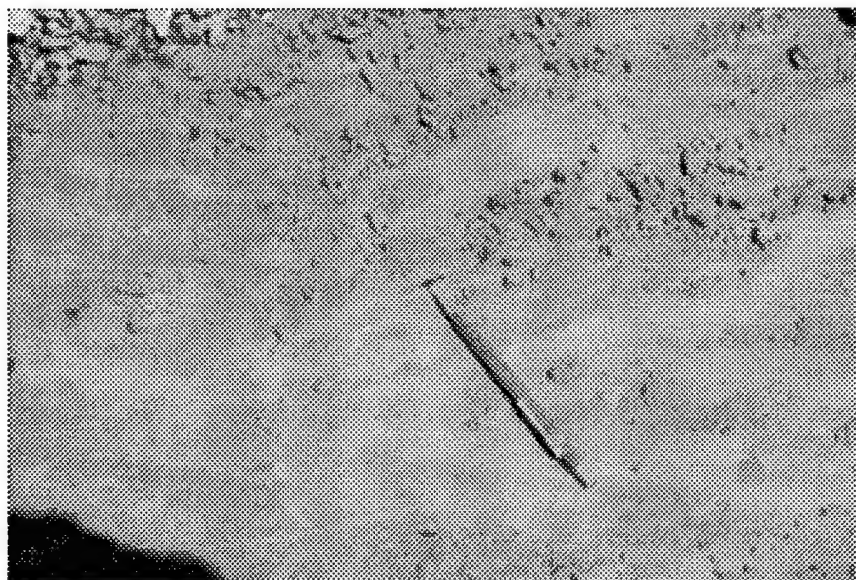
Figure 33. Ballast contained a lot of fine soil where core 19 was taken. Note the membrane slit at the upper end of the pencil.

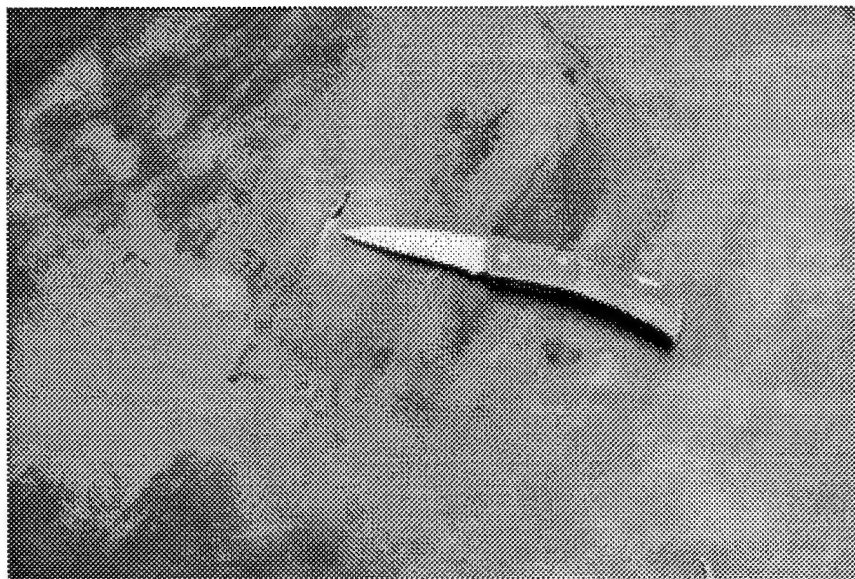
Figure 34. The membrane slit shown in Figure 33 after cleaning the membrane.

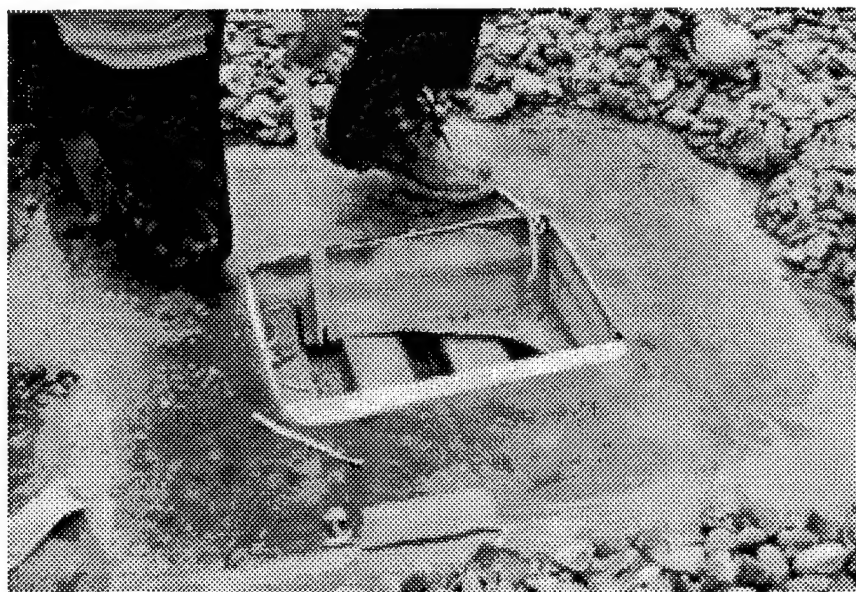
Figure 35. Cut H on roof A2. A small amount of rust was present in the flutes of the steel deck.

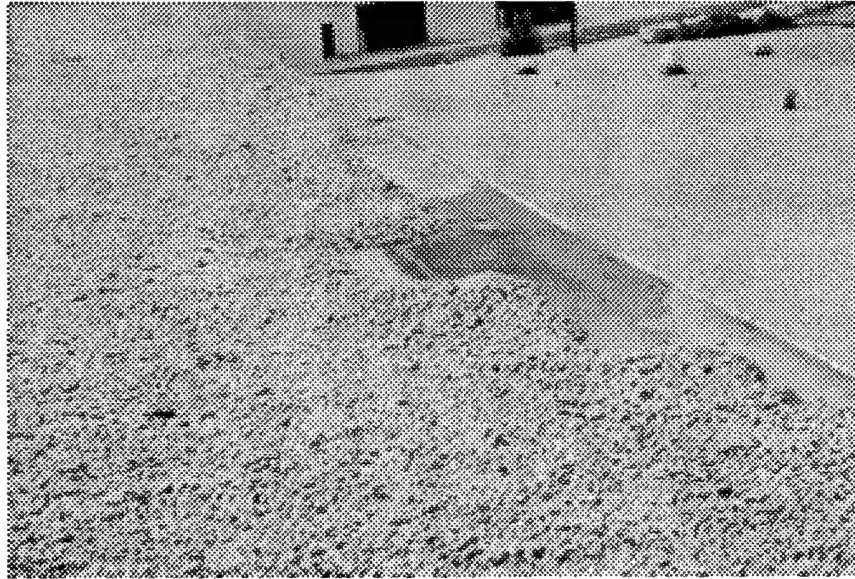
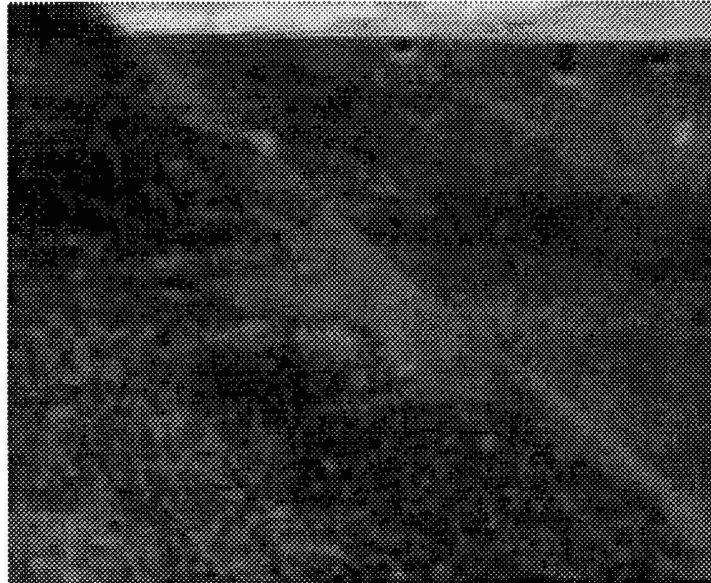
Figure 36. Photograph and thermogram of bare membrane and ponded water along the west side of roof A3, looking SW.
